SANITARY WARE SPECIFICATION SHEET

Report No. : PHY200012

REPORT ON LOADING TEST OF GRAB BAR

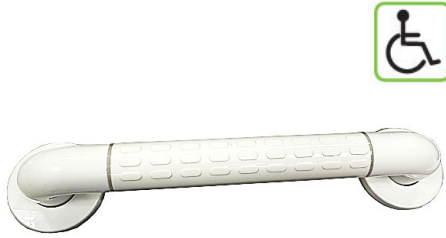
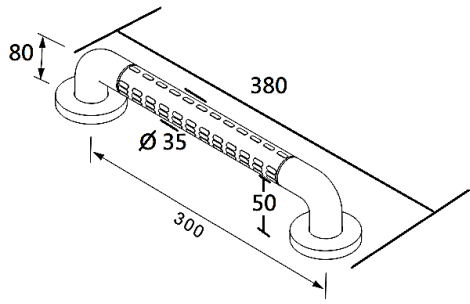
| Item Descriptions | SODUN (PRC) Ø35 x 300mm long white ABS coated aluminium grip grab rail ; BS12:1978 & BS882:1973 capable of carrying a static loading test 150kg ; test report PHY200012 ; complied with Barrier Free Access 2008 | <p style="text-align: center;">Illustration/ Drawing</p> <p style="text-align: center;">anti-slip</p> |

| Dimensions | 300mm x Ø35 mm | |

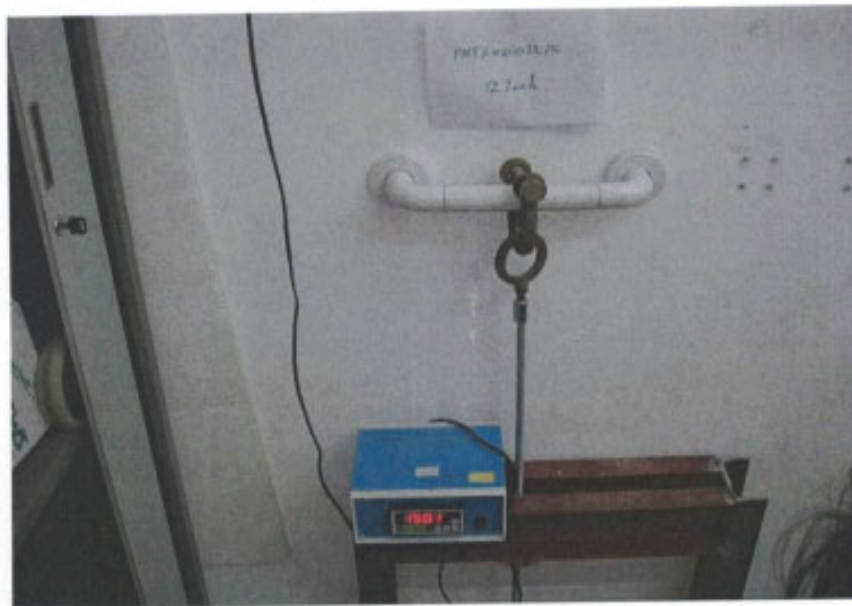
Test configuration

Test description: The grab handle was mounted on a concrete wall. A test load was applied vertically to the mid point of the handle for 5 minute which was then examined for any signs of damage.

| Lab Sample ID | Test Load (kg) | Duration (minute) | Visual damage (e.g. breakage, significant permanent deformation, etc) | Result |
|---|---|---|---|---|
| PHY200012/5 | 150 | 5 | No visual damage | Pass |
