SANITARY WARE SPECIFICATION SHEET

Report No. : PHY200012(3)

REPORT ON LOADING TEST OF GRAB BAR

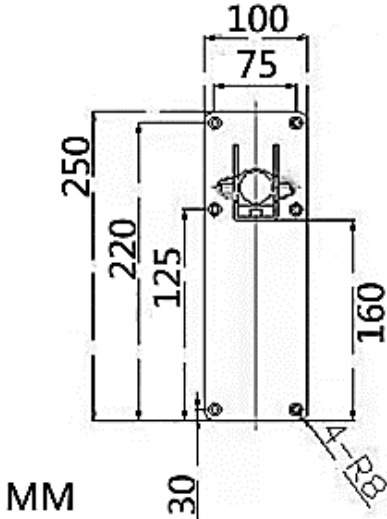
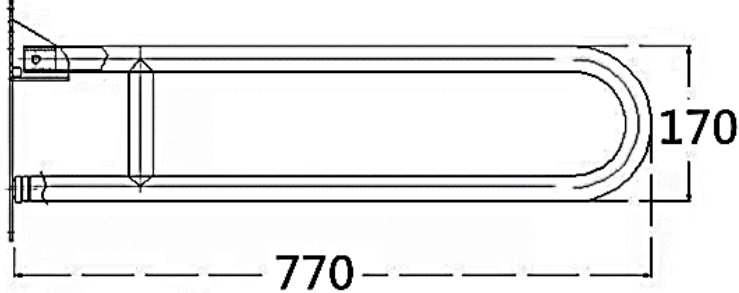
<p>Item Descriptions</p> <p>Dimensions</p> <p>Model</p> <p>Finish</p> <p>Manufacturer</p> <p>Supplier</p> <p>Contact Tel/Fax</p> <p>E-mail</p> <p>Website</p>	<p>SODUN (PRC) Ø32 x 770mm long stainless steel 304 hinged support rail in satin finish; of carrying a static loading test 150kg ; test report PHY200012(3) ; complied with Barrier Free Access 2008</p> <p>32mm dia x 770mm long</p> <p>803-FU760</p> <p>Stainless Steel</p> <p>SODUN (PRC)</p> <p>Ka Shing Enterprises (H.K.) Limited Mr. Ivan Lau / Mr. GilmanYuen</p> <p>(852) 2628-0661 / (852) 2490-2700 kashing.project@gmail.com www.kashingehk.com</p>	<p>Illustration/ Drawing </p>

<p>MM</p>
<p>配件：爆炸螺丝M8</p>

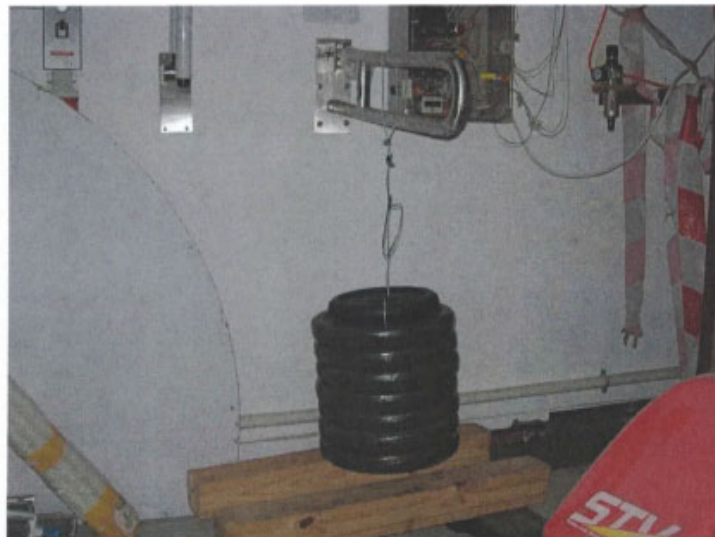
Test configuration

Lab Sample ID	Test Load (kg)	Duration (minute)	Visual damage (e.g. breakage, significant permanent deformation, etc)	Result
PHY200012/1	150	5	No visual damage	Pass

Test description: The grab bar was mounted on a concrete wall. A test load was applied vertically to the mid point of the bar for 5 minute which was then examined for any signs of damage.
