## SANITARY WARE SPECIFICATION SHEET

## **REPORT ON LOADING TEST OF GRAB BAR**

Client : Ka Shing Enterprises (H.K.) Limited  
Project : Loading test of grab bar - 150kg  
Sample Description : Plastic wrapped foldable grab bar (包膠傷殘扶手)  
Model No. : S-8900

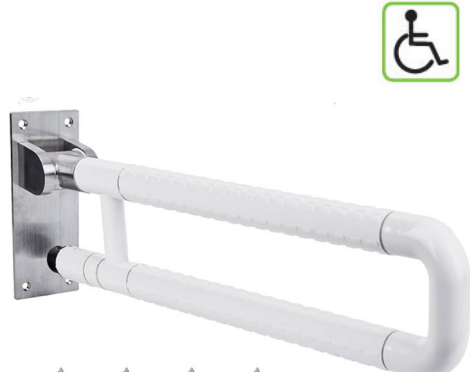
Item Descriptions	SODUN (PRC) Ø35 x 780mm long white ABS coated aluminium grip grab rail ;BS12:1978 & BS882:1973 capable of carrying a <b>static loading test 150kg</b> ; test report PHY200012(2) ; complied with Barrier Free Access 2008	<p style="text-align: center;">Illustration/ Drawing</p>

<p style="text-align: center;">anti-slip</p>

Dimensions	780 mm x Ø35 mm	
Model	S-8900	
Material/ Color	ABS Coated Aluminum/ White	
Manufacturer	SODUN (PRC)	
Source	Ka Shing Enterprises (H.K) Limited Mr. Ivan Lau / Mr. GilmanYuen	
Contact Tel/Fax	(852) 2628-0661 / (852) 2490-2700	
E-mail	kashing.project@gmail.com	
Website	www.kashingehk.com

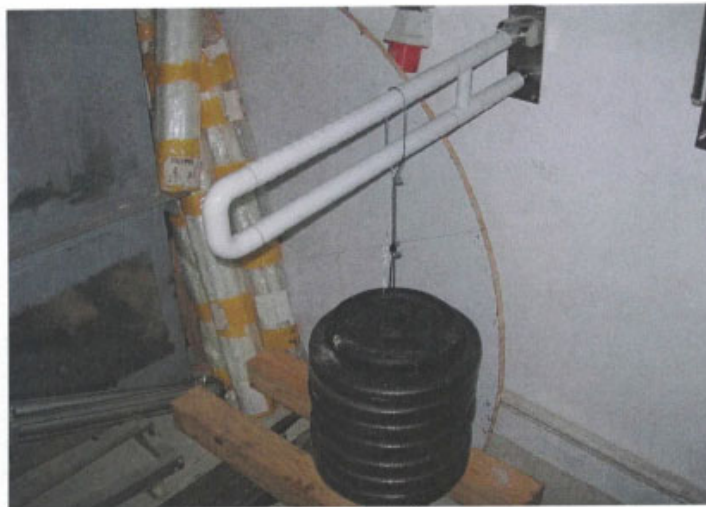
Test description: The grab bar was mounted on a concrete wall. A test load was applied vertically to the mid point of the bar for 5 minute which was then examined for any signs of damage.

Test configuration

Lab Sample ID	Test Load (kg)	Duration (minute)	Visual damage (e.g. breakage, significant permanent deformation, etc)	Result
PHY200012/2	150	5	No visual damage	Pass
