SANITARY WARE SPECIFICATION SHEET

80mm Seal Top Access Bath Trap With Overflow

REPORT ON TESTING OF TRAP

Client :
Project : Testing of Trap
Sample Description : "McAlpine" 40mm dia. Top access resealing bath trap with foot operated pop up waste
Model No. : FJ10WRTA-S

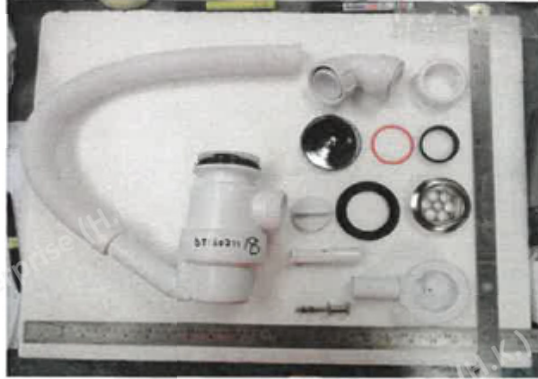
Test Sample
Sample I.D.: ST160211/8

- Remark : 1.) The results of the report relate only to the samples tested.
2.) The test sample is shown in the photograph on page 4 of this report.
3.) This report is to supersede our previous test report no. 154502ST160211(7).
